A Need to “Flush” Out High Concentration Heparin Products

ISMP Canada has received a medication error report involving heparin. The information has been shared by a hospital to provide an alert to other hospitals and healthcare providers.

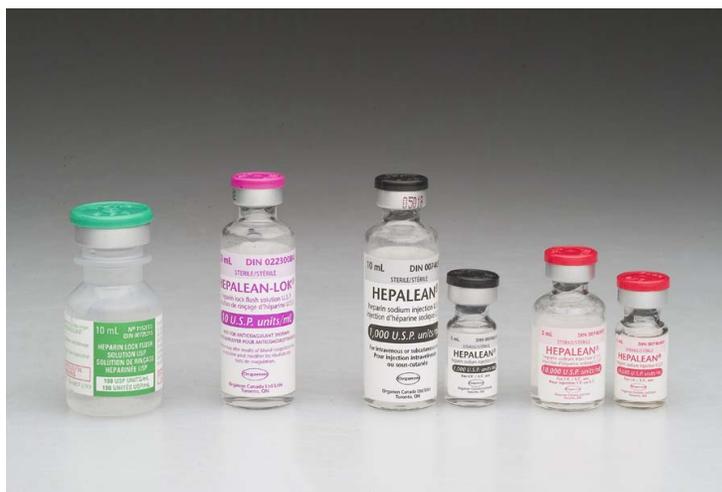
Figure 1: From left to right: Heparin Lock Flush 100 units/mL (green); Hepalean-Lok® 10 units/mL (pink); Heparin injection 1,000 units/mL - 10mL and 1mL (black); and Heparin 10,000 units/mL - 5mL and 1mL (red).

Different concentrations, while packaged in vials with differently coloured caps and matching coloured labels are supplied in identically sized and shaped vials. This necessitates a very careful evaluation of both the range of heparin products required for use in hospital, and those which will be made available in patient care areas. **Patient injury as a result of a substitution error can occur in any hospital where vials of concentrated heparin, such as 10,000 units/mL, are available in patient care areas.**

- 1) Eliminate the 10,000 units/mL formats of heparin from patient care area medication stock.
 - Use marketed, pre-mixed solutions of heparin for intravenous (IV) indications.
 - Purchase single-dose heparin such as the 5,000 units/0.2 mL ampoule (or the pre-filled heparin
