Secondary Infusions Require “Primary” Attention

Look-alike Product Alert

Calcium Gluconate Injection 10mL vial Label

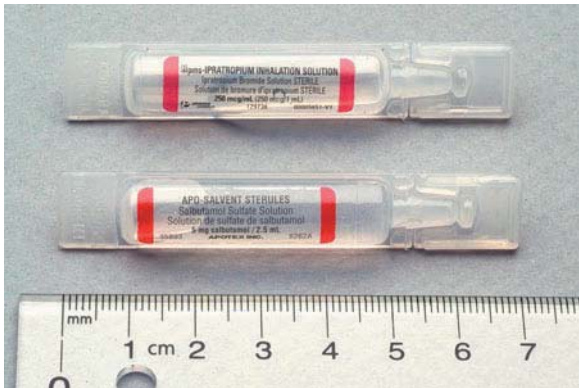
A Registered Respiratory Therapist (also referred to as a Registered Respiratory Care Practitioner) reported a near miss involving look-alike nebulers of ipratropium bromide solution for inhalation from PharmaScience and salbutamol solution for inhalation from Apotex (Figure 1). ISMP Canada has contacted both companies to alert them to this problem. ISMP Canada recommends that hospitals:

Figure 1. Look-alike nebulers of ipratropium bromide solution for inhalation and salbutamol solution for inhalation.

- Include a process to evaluate new products (or changes to existing product packaging and labels) for potential look-alike confusion. As in this instance, purchasing products from alternate manufacturers does not guarantee reduced look-alike potential.
- Evaluate formulary products with the end-user in mind and favour the selection of products which prominently display critical information on the label.
- Store nebulers in their original packaging whenever possible.

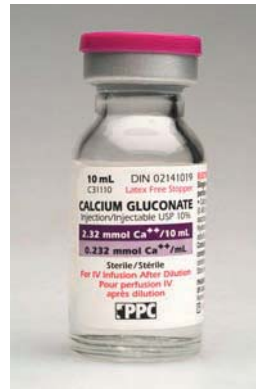
ISMP Canada received concerns about the labelling of the product (Figure 2) and through collaborative efforts with health care professionals and PPC important changes to the label are being implemented (Figure 3):

Figure 2. Existing label for calcium gluconate injection 10mL vial

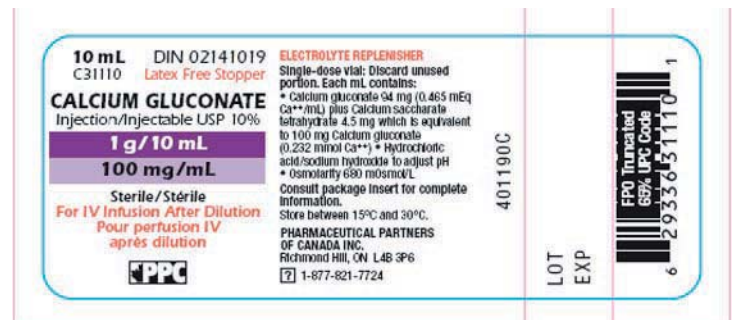
Figure 3. New label for calcium gluconate injection 10mL vial

- '1g/10mL' will be added to the front label in a prominent fashion (defined as critical information)
- the equivalency in mmol will be provided on the back label
- the PPC logo will be reduced in size to facilitate prominent display of all critical information.
